CONSULTATION SERVICES TO RESPOND, RECTIFY, AND RESTORE

ON THE JOBSITE

THE PROBLEM

New medium voltage (MV) cables were damaged during handling and transit, allowing moisture penetration along the reel.

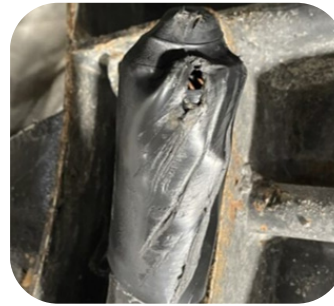
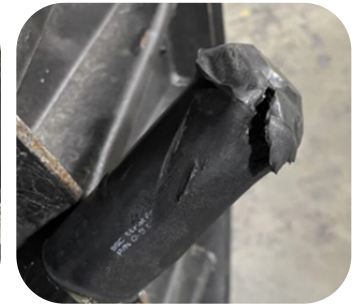
THE PROBLEM

Cable ends were damaged during handling and transit, causing a tear on the end caps.

Three new 15 kV primary MV cables were damaged during handling and transit, causing a tear on the factory-installed end caps, as shown in the pictures. These torn heat-shrinkable rubber seals failed to protect the exposed cable ends from unforeseen moisture, allowing rainwater to penetrate the cable longitudinally on the reel because of “Capillary Action”. The electrical contractor contacted Southwire sales and requested emergency engineering support.

Southwire CableTechSupport™ Services team traveled to the construction site and inspected the new cables. Our hands-on field expert purged the wet cables using high-pressure compressed nitrogen gas cylinders to push out the rainwater. The purging efforts took a few days to complete due to the design and the long-length of cable on the reel. A moisture indicator was deployed to check the water content during purging until a satisfactory degree of dryness was achieved.

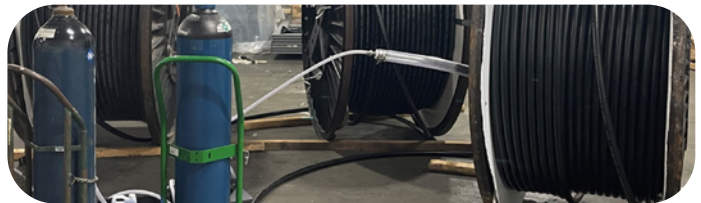
Purging cables using compressed nitrogen gas.

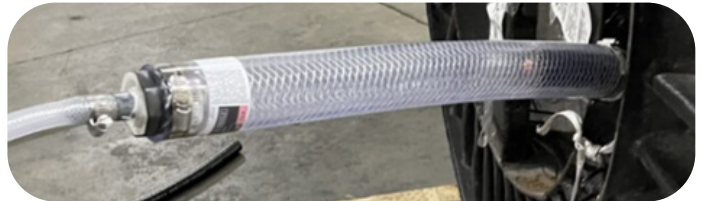
Purging took a few days to complete due to the cable design and its long length.
